# SERVICE INFORMATION

## STANDARD AND TRIUMPH VEHICLES (NOT FOR PUBLICATION)

**No.** EIGHT/2/M SUPPRESSION OF RADIO AND TELEVISION **Date** JANUARY 1954  
(AND OTHER MODELS) INTERFERENCE

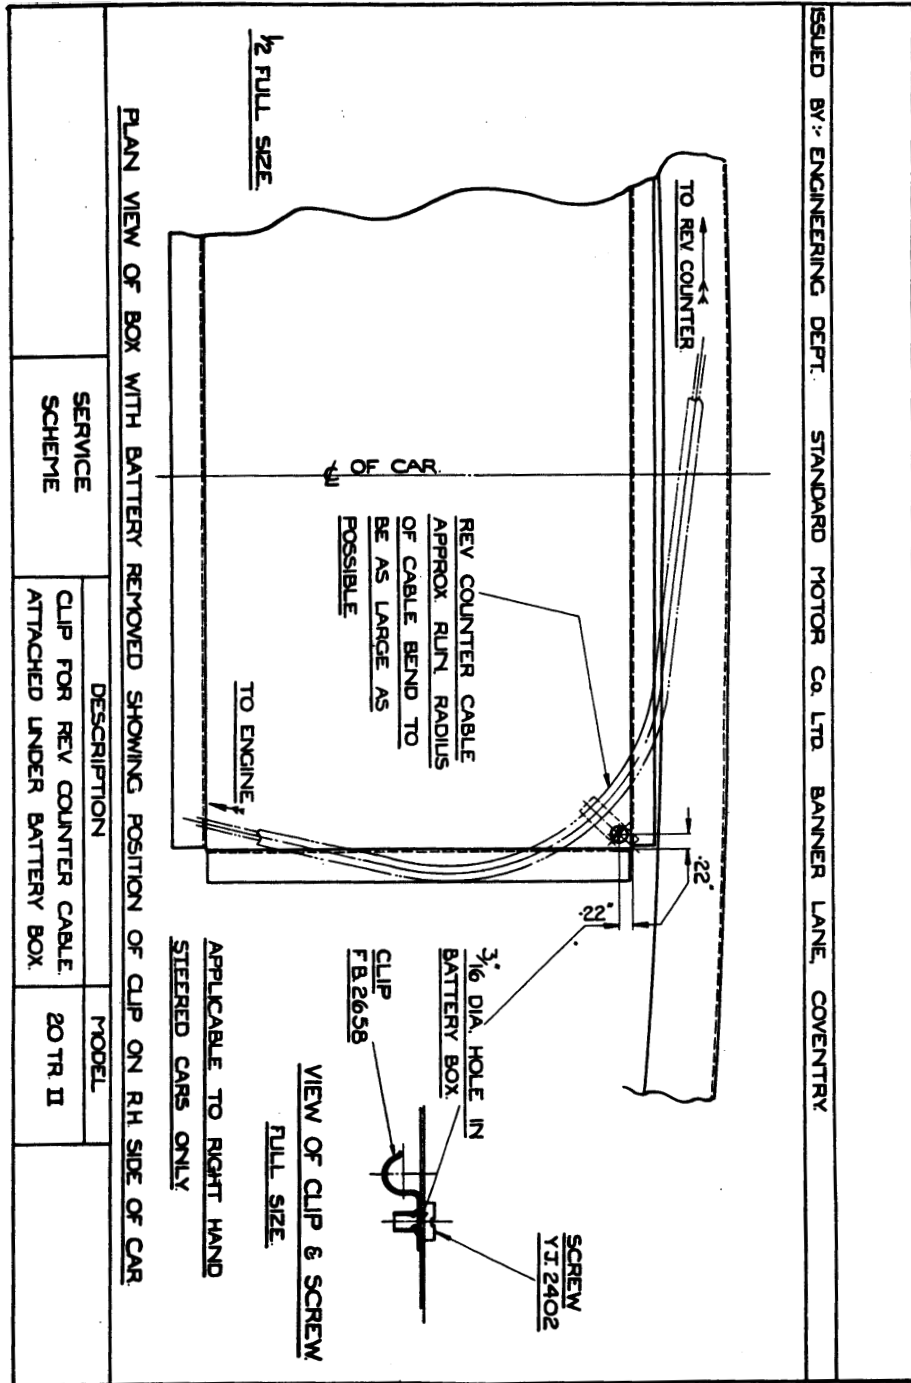
There have been instances of instrument failure Which, upon examination, have been found to be due to excessive end loading of the operating mechanism.

This has generally been caused by the fit of the square ends of the inner cable being too tight, either in the instrument, or in the engine drive attachment.

There have been cases of inner cable fracture due to sharp bends in the "run" of the outer cable on R.H.S. Models. The "run" has now been improved in factory assembly to minimise the possibility of such a condition and the modified "run" is shown in the illustration.

The inner cable should be checked for free fitting at both ends and particularly so at the engine drive. It will be necessary to ease or replace the engine drive socket if the square recess in the socket is undersize.

It is most important that both the cable for this instrument, and also that for the speedometer, are not "kinked" during installation, as once distortion of the inner cable has taken place early failure is inevitable, however correct is the subsequent run of the cable. It should be general practice to finally check the run of the cable to ensure the maximum possible radius for each bend, especially where it is "clipped" or passes through bulkheads.

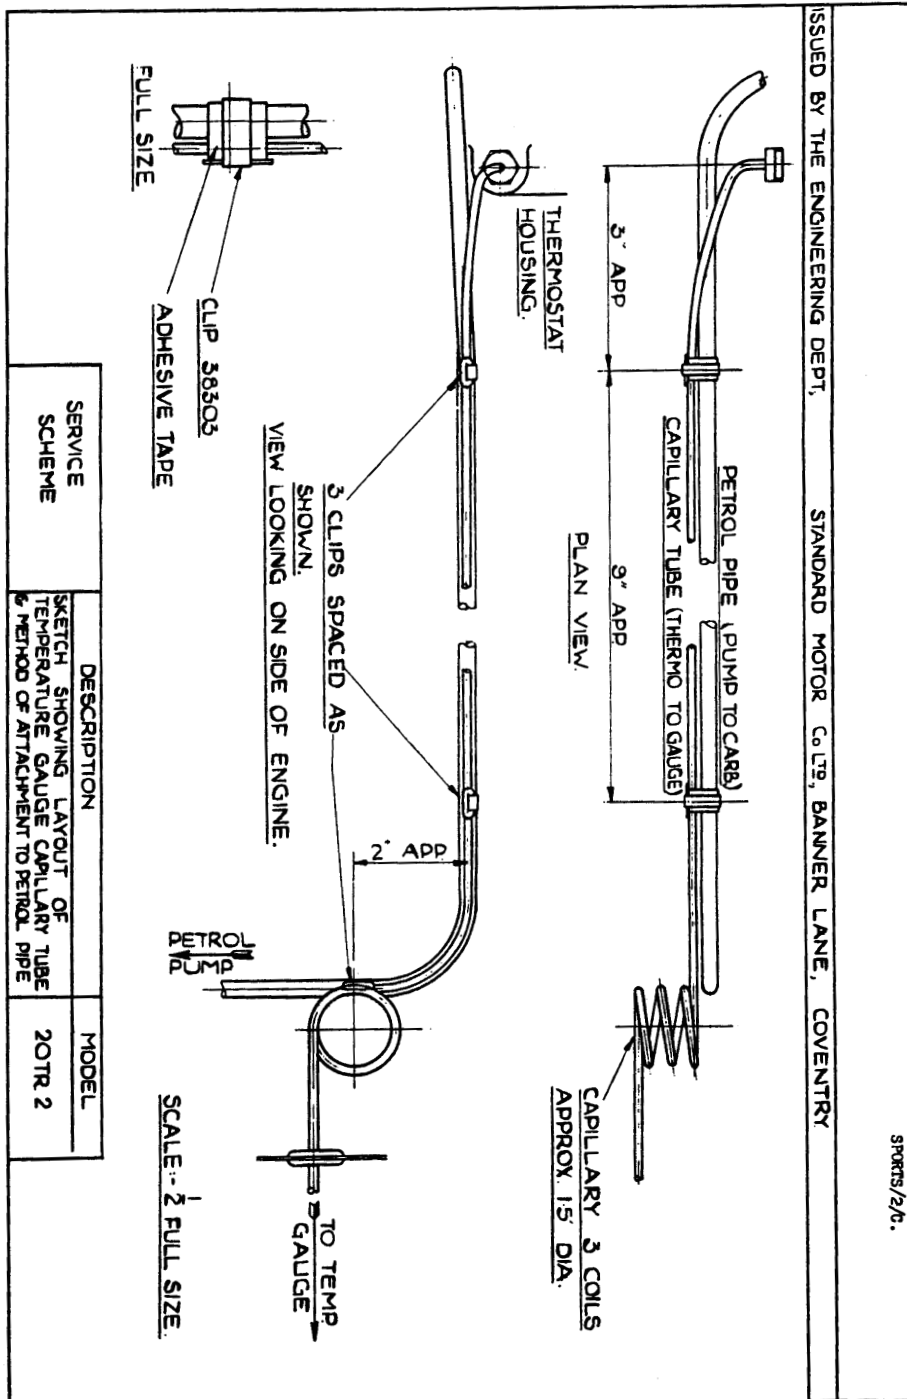
There have been instances of failure of this unit, owing to the cracking of the capillary tube, where it enters the thermometer bulb, with consequent loss of filling fluid.

Tests have shown that the run of the capillary tube adjacent to the thermometer can cause a pronounced vibration period at certain engine speeds. This period, apart from normal handling damage, has been responsible for the majority of failures examined.

The illustration shows the correct "run" for the capillary tube when fitting replacements and should be used, where a car is found not to conform with this arrangement of the capillary tube, when carrying out normal servicing operations.

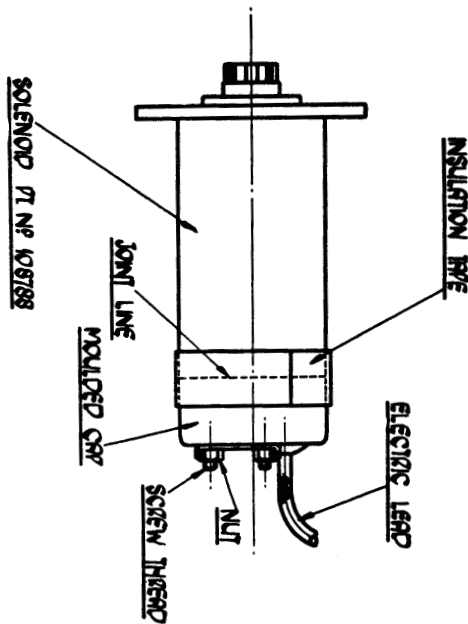
There have been complaints of failure of the operating solenoid for the control mechanism due to water entry into this solenoid.

1. WARP 3 COMPLETE TURNS OF 1/2" WIDE INSULATION TAPE AROUND JOINT BETWEEN THE METAL BODY AND THE BLACK MOUNTED CAP. TAPE IS TO BE CENTRALLY WAPPED OVER JOINT LINE AS ILLUSTRATED

SAVINGS AND SERVICE SCHEME	DESCRIPTION	REMARKS
	REPLACES 1 SERVICE SCHEME STOPPING METHOD OF SEALING PACKED BLACK CAP OF SOLENOID PT. NO. 108788 AGAINST ENTRY OF MOISTURE.	NO S.I. ELECTRIC OVERDENE

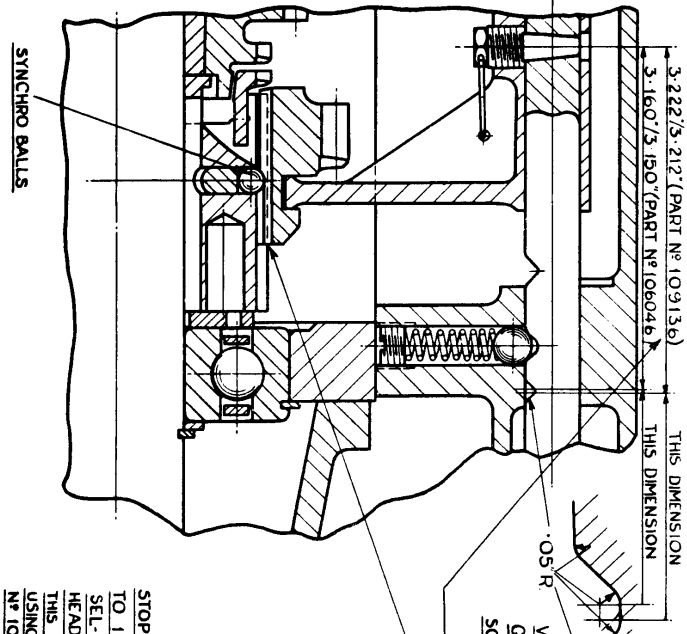
On earlier gearboxes it was possible, with certain combinations of limits, to have inadequate engagement on the flank of the dog teeth. This condition, apart from the crushing and bruising, owing to the small bearing area which permitted overdrive load to be carried on all dog teeth, allowed the gear to slip out when subjected to any appreciable over-run load.

The "Second" speed mainshaft gears will generally have to be replaced owing to the dog teeth having been previously damaged by inadequate meshing.

DESCRIPTION	SERVICE SCHEME SHOWING MODIFICATION NECESSARY TO ENSURE ADEQUATE ENGAGEMENT OF 2 <sup>ND</sup> GEAR.
MODEL	20. TR. 2.

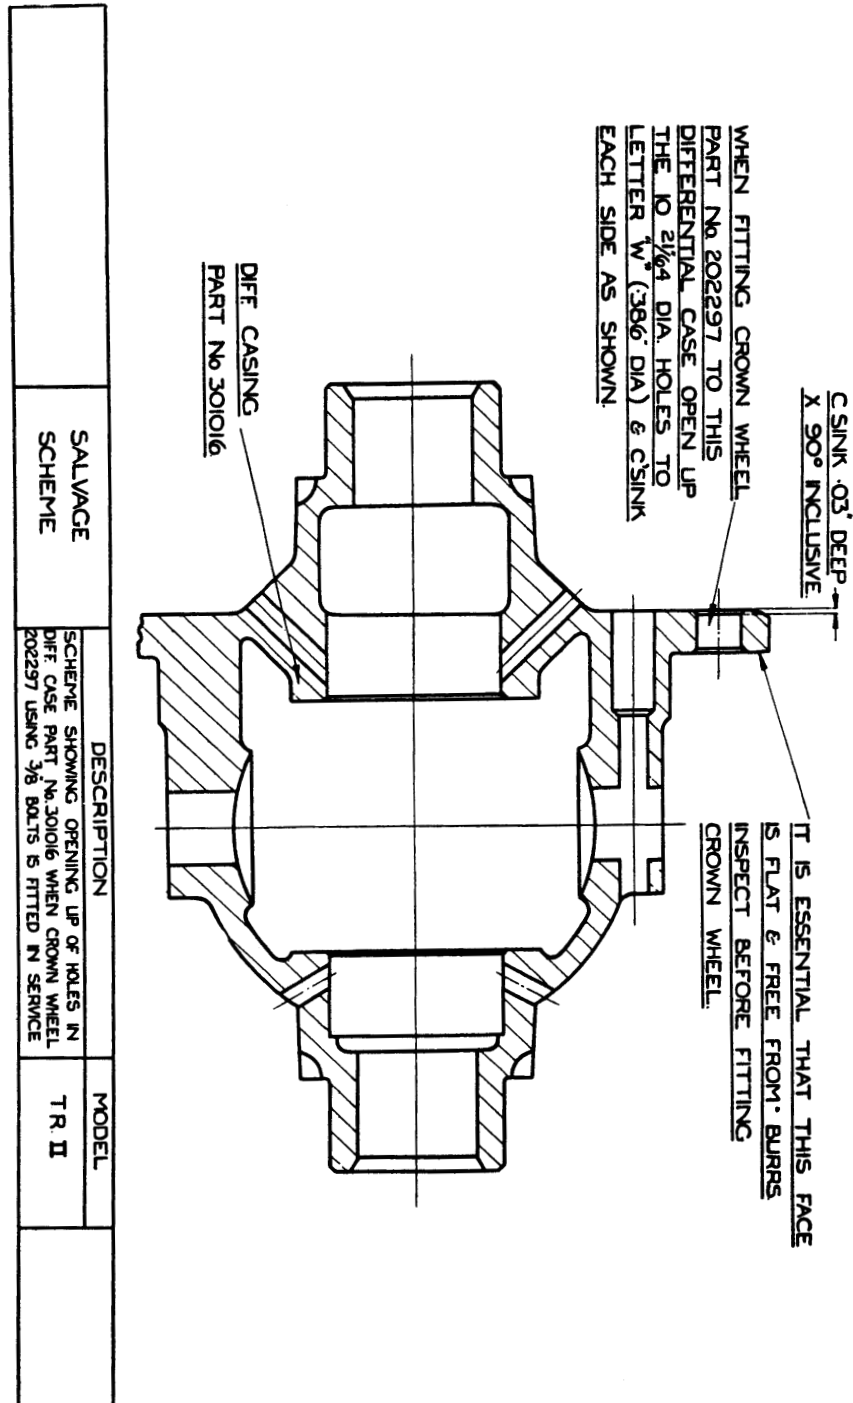
The crown wheel has shown a tendency to work loose on the differential housing after exacting rally forward and reversing tests, and it is recommended that the bolts should be checked for tightness to 22-24 lbs. ft. after the vehicle has competed in this type of event.

SALVAGE SCHEME	DESCRIPTION SCHEME SHOWING OPENING UP OF HOLES IN DIFF. CASE PART No. 301016 WHEN CROWN WHEEL 202297 USING $\frac{3}{8}$ BOLTS IS FITTED IN SERVICE	MODEL T.R. II	
--	----------------	--	------------------	--

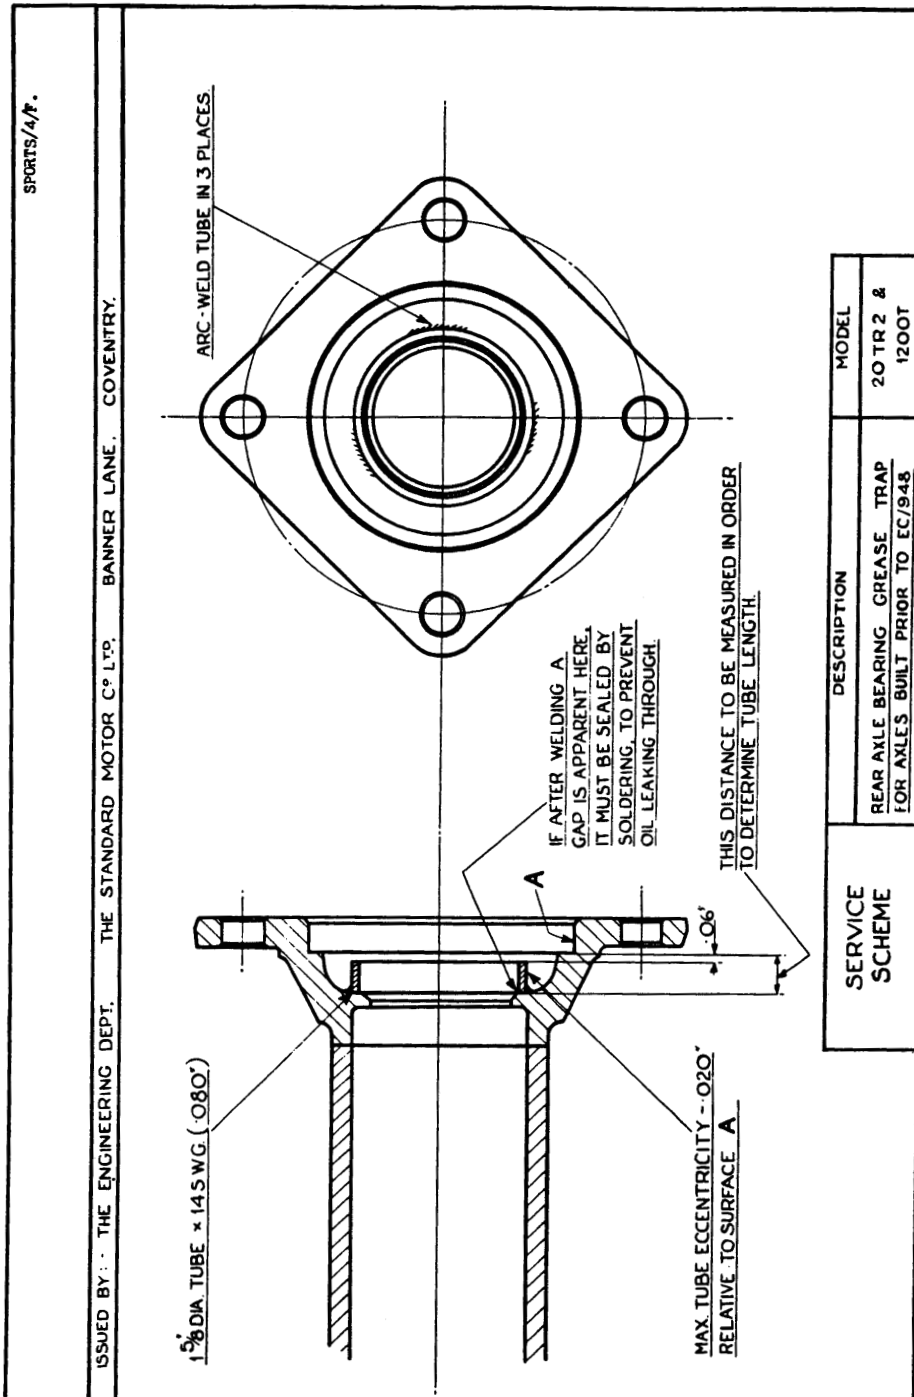
A few instances of this type of trouble have occurred, which could not be explained by damage due to the incorrect method of assembling the press fit rear hub described in Service Information Sheet SPORTS/3/F.

A careful investigation has been carried out, as to a possible explanation for those failures, and we are satisfied that they have been caused by the washing action of the axle oil on the grease when cornering. This washing action has left the bearing running with only a thin film of back axle oil.

Rear axles are to be modified in normal production to incorporate a grease trap similar to that shown in the illustration. This baffle serves a double purpose, it minimises the washing effect of the axle oil on the grease and ensures that a certain amount of the lubricant is always retained under the lower lip under any conditions of cornering to which the car is likely to be subjected.

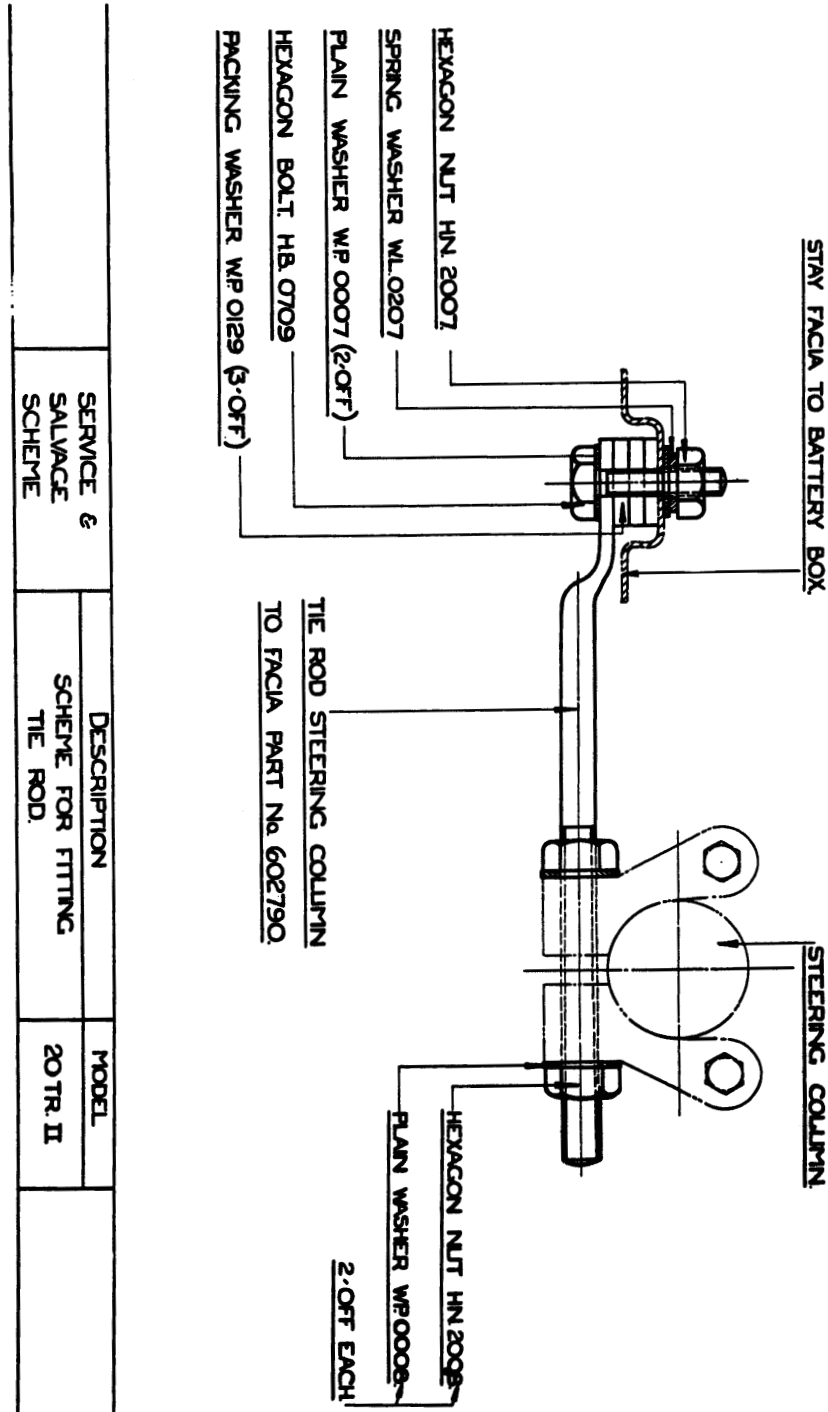
There is a tendency with some cars of this type to develop excessive sideways movement of the steering wheel under certain road conditions.

SERVICE & SALVAGE SCHEME	DESCRIPTION	MODEL
SCHEME FOR FITTING THE ROD.	20 TR II

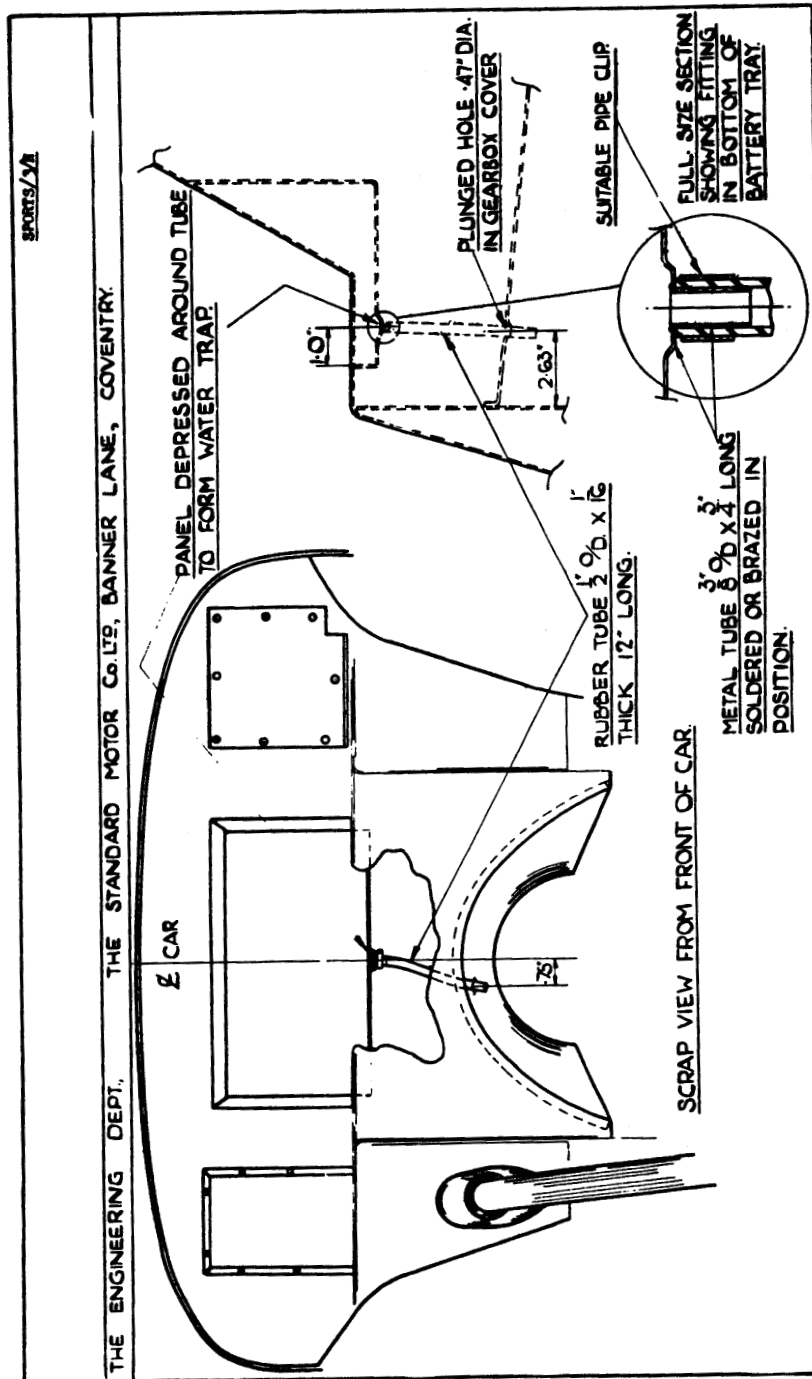
Isolated cases of water entering the Battery container box have been reported, where cars are used in thunderstorms, or under similar conditions of rainfall experienced in some tropical areas. The water finds its way, under such conditions, into the battery box owing to "build up" at the rear of the bonnet.

SERVICE SCHEME	DESCRIPTION	MODEL
	SCHEME FOR DRAINING BATTERY COMPARTMENT.	20TR. 2
