'Bias' Spring Adjustment

The LT77 Rover Transmission on the Morgan Plus 8 is a 5 Speed Manual gearbox. This is a very robust transmission but like anything mechanical, things can and do go awry. No need to worry though, they are usually an easy fix.

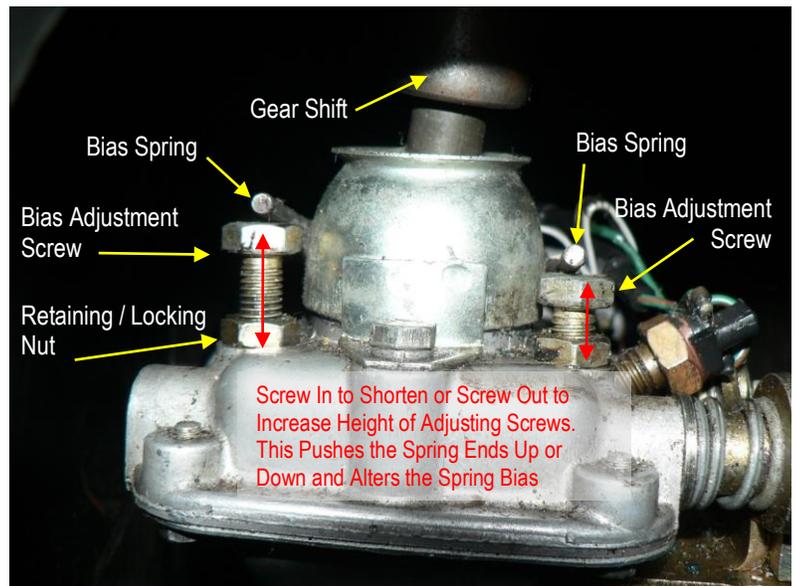
One of the known issues with this transmission is with the remote shifting mechanism. This remote shifter is provided with a wire spring that is used to adjust the shifter's side to side alignment. This spring is known as the 'bias' spring. (Note – Just the end of the wire spring can be seen in the picture.)

It is adjusted by raising and lowering bolts that govern the spring's relative position. Raise the adjustment screw / bolt on the right side (backing the bolt out or loosening it some) higher than the adjustment screw / bolt on the left and the gear shift handle tilts a bit to the left (with a predilection for 1st and 2nd). Raise the left side bolt (above the bolt on the right side) and the gear shift handle tilts a bit to the right (with a predilection for 3rd and 4th). (This configuration is shown in the picture.)

The shift mechanism on this car was set with way too much 'bias' towards 1st and 2nd (e.g. the left side bolt was screwed in way too far or too low) hence the inability to get into 3rd and/or 4th easily. I raised the left side a good ¼" and lowered the right side about the same, to get the shifter to 'bias' to the right side gears (3rd and 4th). It is now pretty well balanced. 3rd and 4th gear are easily obtained and not the struggle they were before.

Each of the adjusting bolts has a locking or retaining nut that precludes the adjusting nuts from moving. On this car, both of these locking nuts were loose and I suspect that is why the spring bias adjusting nuts were too low. They must have vibrated and screwed themselves in/down over time.
