LAND ROVER FUEL INJECTION SYSTEM

DESIGN AND FABRICATION

This paper describes the conversion of the existing carburetion system to a fuel injection system in full and is designed as a maintenance aid.

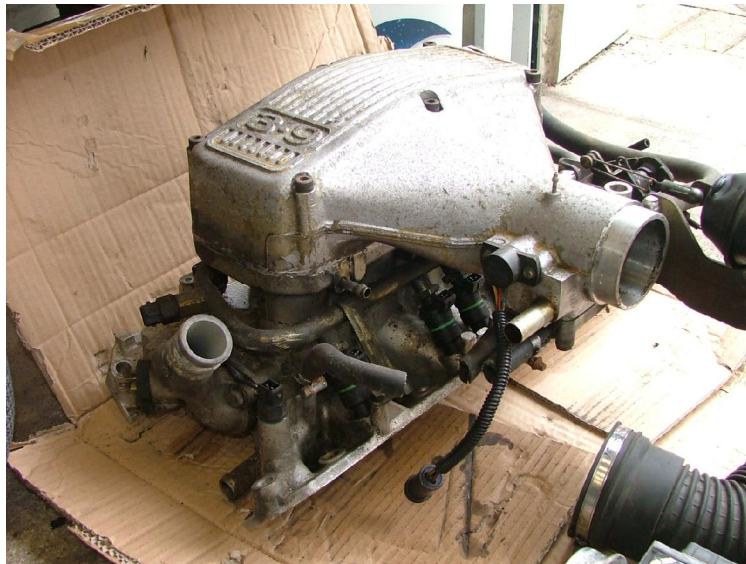
Figure 1 – 1992 3.9EFI donor vehicle parts as shipped

The general condition of the donor parts was good and it was clear that the seller had done a good job of carefully removing the components in order to minimise damage.

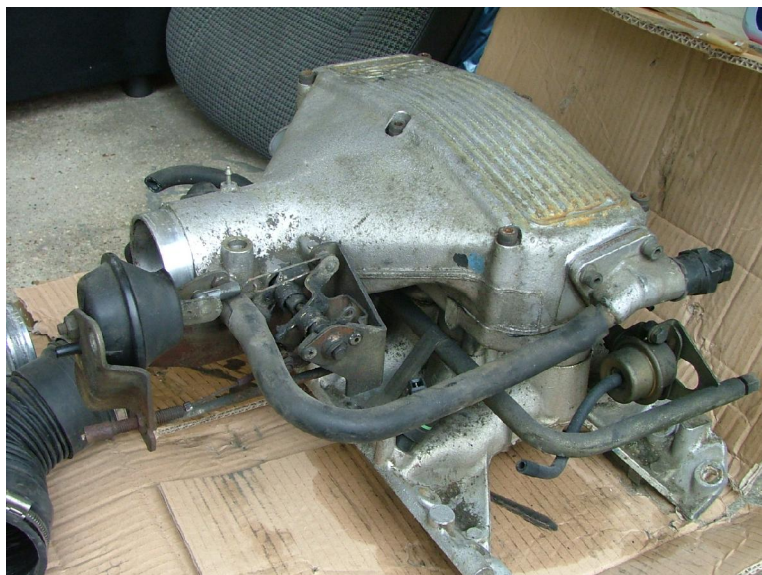
Figure 2 – Plenum side view

The idle control system was intact, as was the throttle linkages and the fuel regulator (at the back of the fuel rail). The throttle linkages did however appear to be in a bad state of repair.

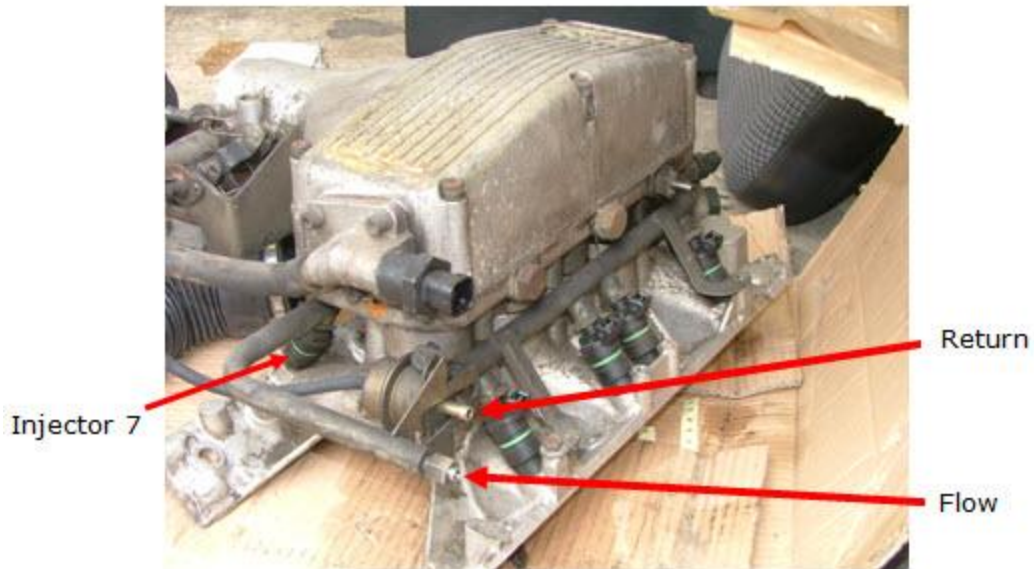
Figure 3 – Plenum rear quarter view – fuel flow and return

In the above photograph, you can see the flow and return feed pipes to the fuel rail, connected to the even bank of injectors (with the injector for cylinder 7 visible at the back left). Note the fuel rail connections – using a standard hose jubilee pipe on the low pressure side of the fuel regulator, but a machined fitment on the input high pressure side. This machined connection was tackled by removing the olive and the free rotating nut and using a standard jubilee clip connection on the rail after soldering a lip onto the pipe.

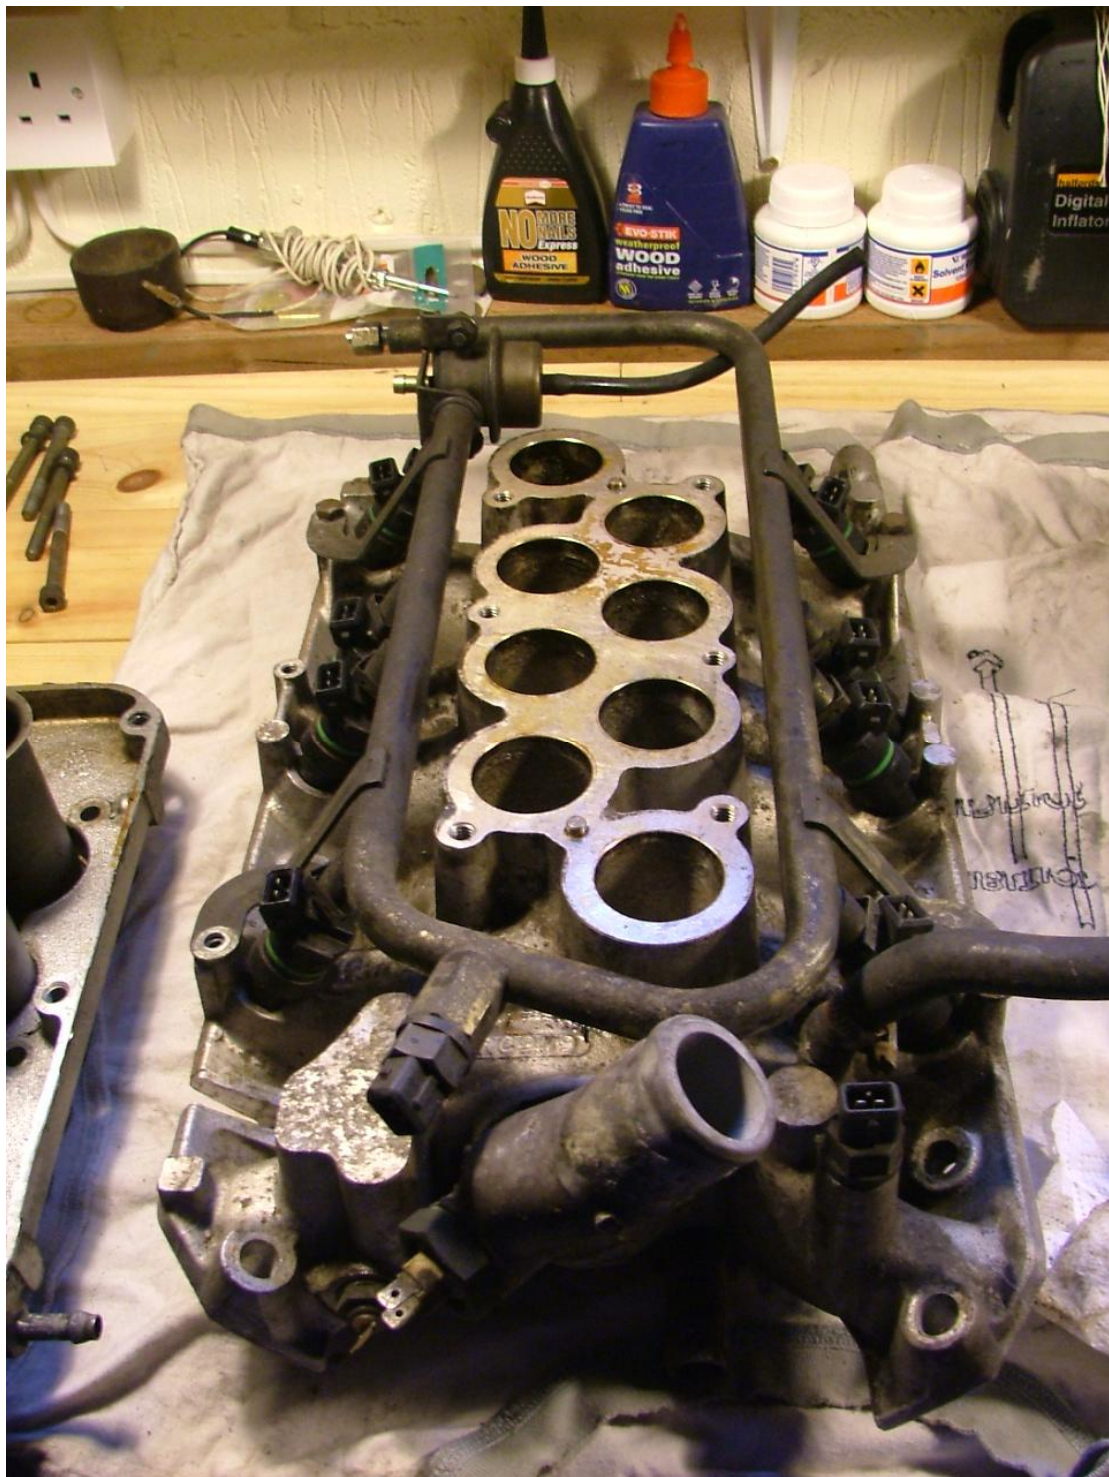
Figure 4 – View of stripped intake manifold

The above photograph details the front of the intake manifold when both the upper plenum and the inner runner manifold have been removed (shown just in shot on the left). Looking at the intake reveals all 8 injectors (the even set of four on the left of the photo, the odd set on the right) connected between the fuel rail and the intake manifold. Note the four bolts (one was missing) fastening the intake to the manifold. You can see the fuel temperature sensor screwed into the front of the fuel rail – and observe that this is not exposed to fuel. The sensor housing is actually brazed to a closed fuel pipe. On the thermostat housing another sensor exists (to drive radiator fans – but which was not employed in my design) and just underneath that is a coolant temp sensor used to drive the dash

At the back of the manifold fuel rail you can see the fuel inlet right at the back coming into the fuel rail, which sweeps round to all 8 injectors exiting into the fuel regulator – with its vacuum hose connected (this hose routes to the vacuum port directly under the idle by pass air valve stepper motor).

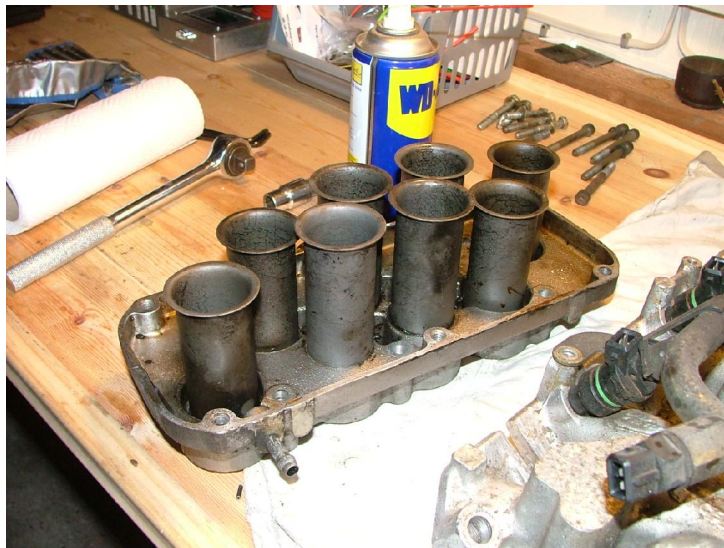
Figure 5 – View of Intake runners

The above photo shows the intake runners which bolt to the intake manifold via 6 bolts, and which the upper plenum (shown below) screws to via 6 hex head screws. An important point to note here is that the intake runner platform is actually reversible – and can be mounted either way on the intake manifold – a design advantage that was used to simplify the vacuum pipe routing.

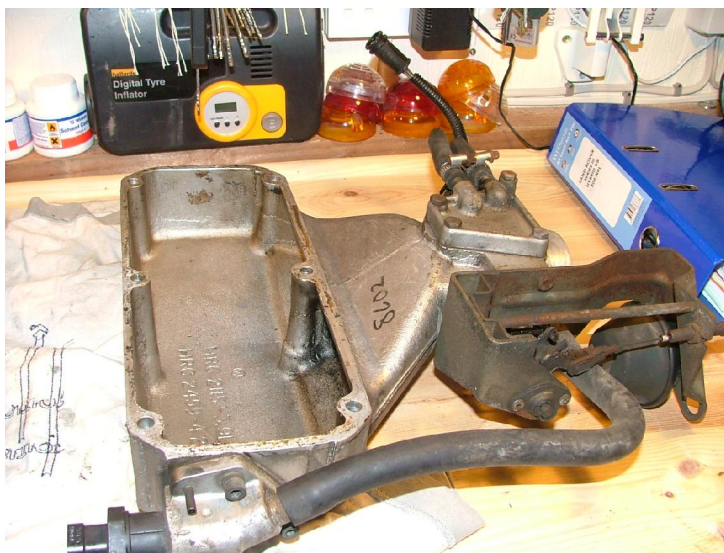
Figure 6 – Underside of plenum.

as well as the throttle linkages. Note also the cable and plug for the throttle potentiometer sensor.

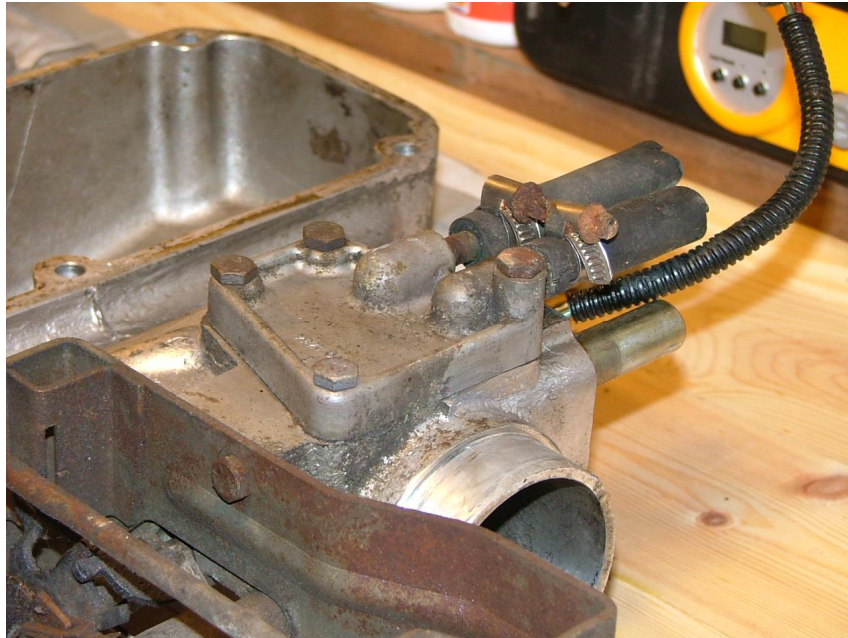
Figure 7 – Close up of plenum chamber pre-heater

The above figure shows the plenum upside down. The primary metered air entry point is the large round point, and the pre-heater plate is shown above with the two heater hoses.

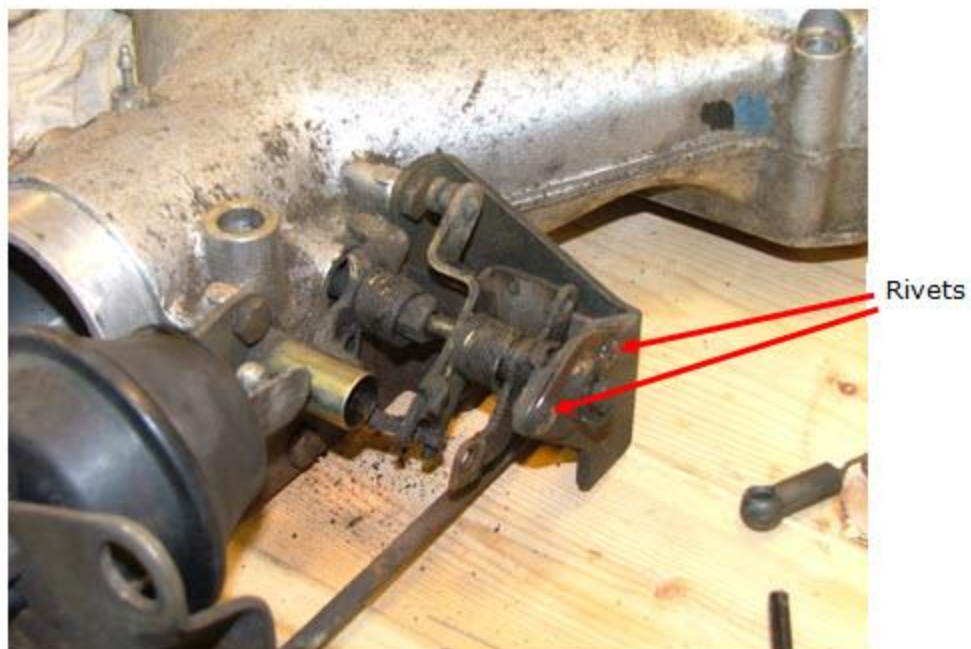
Figure 8 – Close up showing the throttle linkage

The throttle linkage looked in a very bad state during the initial inspection – however after cleaning and refurbishment it quickly became clear that the linkage was in exceptionally good condition with very little wear. Stripping the linkage involved drilling the rivets (shown on the RHS bearing) and replacing.

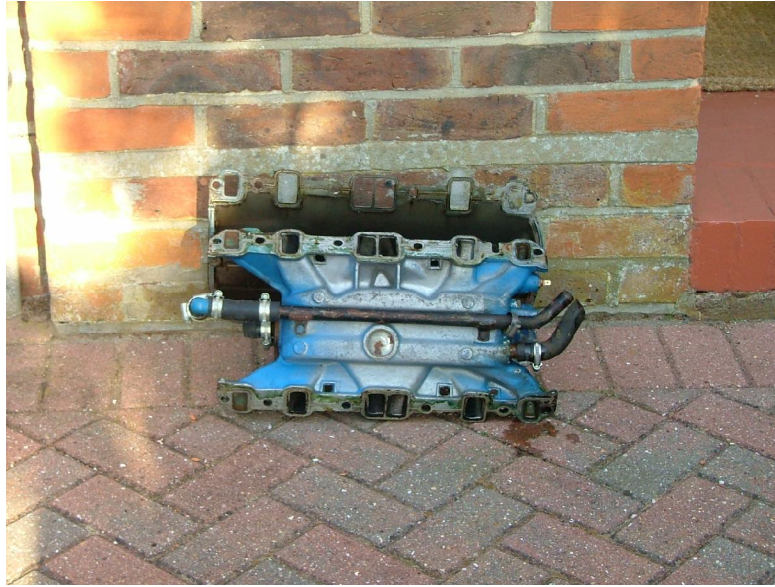
Figure 15 – Underside of original carburettor manifold (showing the plumbing)

With the original intake manifold the top and bottom radiator hoses followed a conventional route – although the top hose was interrupted (close to the radiator) by a metal unit holding two temperature switches designed to operate the two electric radiator fans. Closer to the manifold, the water pump had two ports which connected to hoses – one which was about 4" long and which connected to a corresponding metal pipe in the intake manifold front body (shown above as the bottom right hand most pipe). The second connected to a full length metal pipe screwed to the underside of the manifold. At the back of the manifold the screwed pipe and a second metal pipe in the intake manifold rear body acted as the flow and return feeds for the heater matrix.

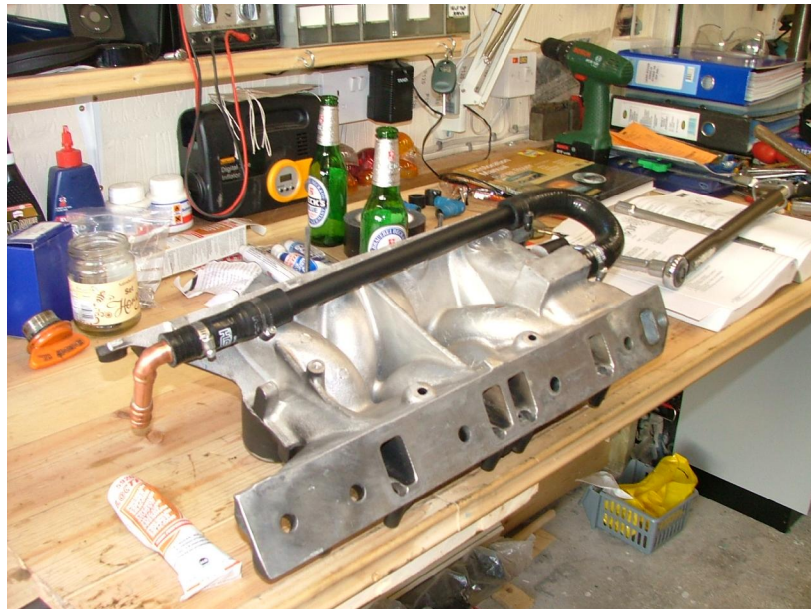
Figure 16 – Underside of injection manifold

The existing steel port on the front of the injection manifold was connected to a 19-19mm U bend in silicon, and routed under the intake using a steel metal pipe. Underneath the manifold (towards the rear) the steel pipe connected to a 19mm to 16mm silicon hose reducer (still under the manifold) and the 16mm outlet was then connected via domestic half inch copper to an upright which connected to a 16-16mm right angle in silicon, connecting to the heater control valve (a sluice valve from an early VW Sirocco mounted on the firewall and shown as "V" in the figure below). On the other side of the sluice valve, a short length of 16mm rubber hose connects to the flow side of the heater matrix.

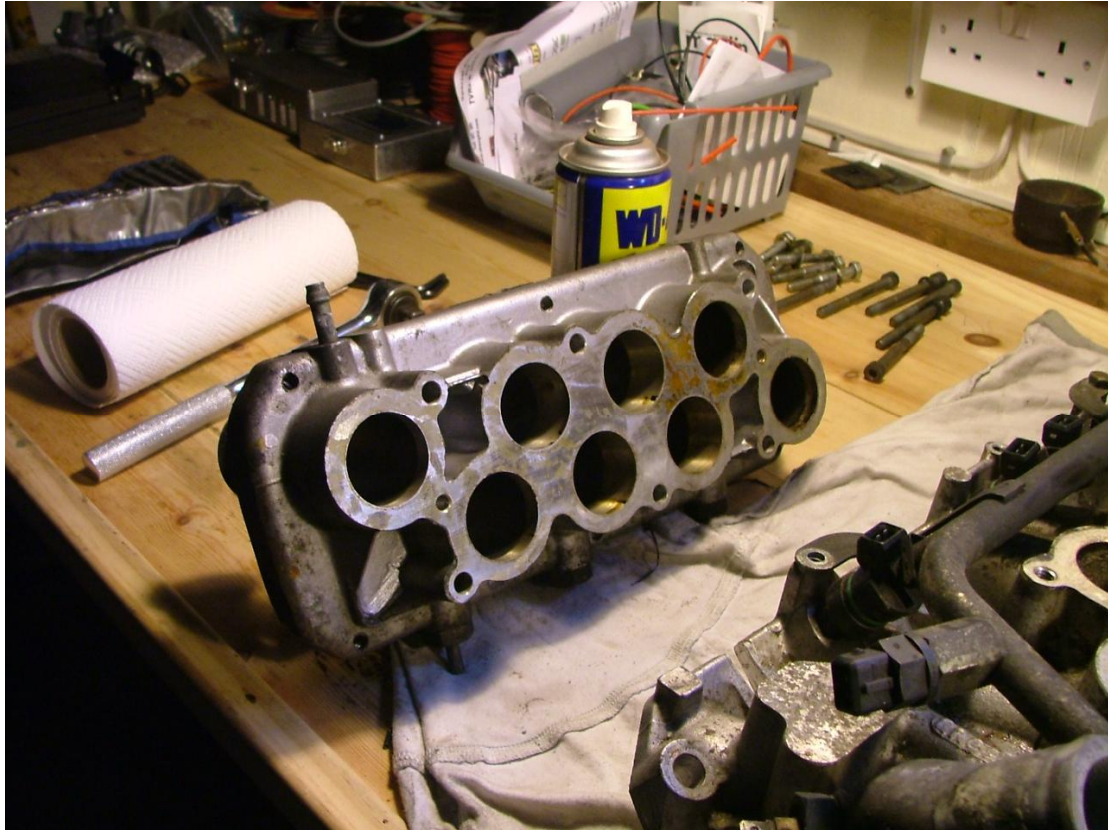
Figure 21 – Underside of plenum intake trumpet housing (note vacuum ports)

The selection of orientation for the trumpets was easy – given it is a reversible section of the intake. The external vacuum ports on the trumpet housing were the deciding factor given the need for the brake servo on one side, and on the other a PCV feed at idle, and the vac gauge. *(Note that the distributor advance/retard is fed from the port on the upper surface of the plenum, and the fuel regulator is fed by the port under the idle bypass air valve stepper motor).*

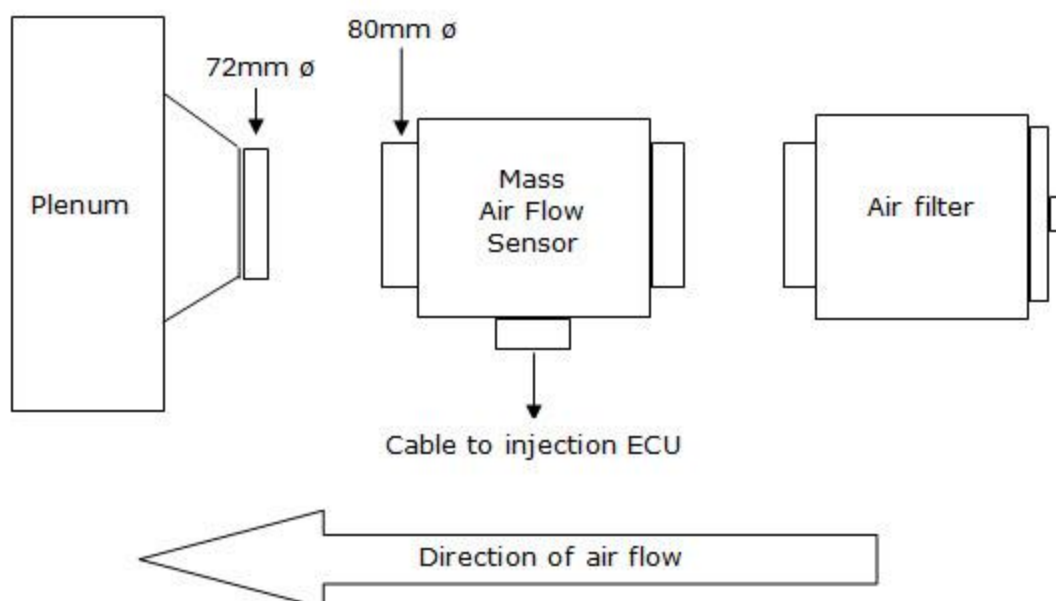
Figure 25 – Mass air flow sensor schematic

The mass air flow sensor is the electronic unit used to measure the precise amount of air entering the engine. It does this by using two wires in a balanced bridge circuit. One wire is exposed to the air flow entering the engine, and the other is encased and hidden. As air flow passes over the exposed wire, it is cooled, and its resistance alters. The bridge circuit measures the difference between the two wires to determine relative air flow.

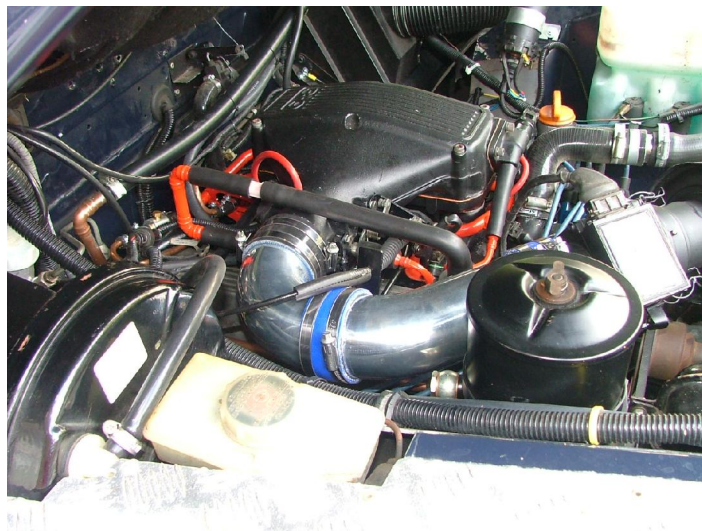
Figure 26 – MAFS air path

The solution (which passed through three different unsatisfactory designs) consisted of the following. First, a 20mm deep stainless steel sleeve was

One complication to this solution was that the 90 degree radius pipe when fitted fouled the throttle assembly frame. In order to resolve this, the entire throttle had to be disassembled, cut and welded to permit adequate clearance while ensuring it was strong enough not to flex.

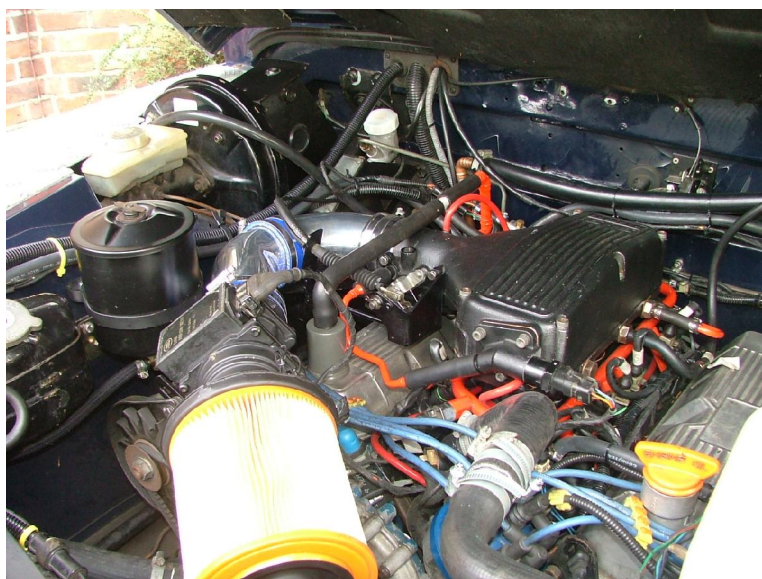
Figure 28 – Mounted air filter (outer canister removed) clipped to MAFS

The donor vehicle air filter unit was the standard Land Rover EFi metal canister unit using a solid clip coupling to the MAFS, a main body and a lid with extended nozzle for the raw air intake. There was interestingly no air preheating feature on this unit. The outer canister steel was also badly rusted on the donor part even though the base was in good condition. An elegant temporary solution involved grinding off the outer canister welds leaving a base with proper clip couplings to the MAFS and an elongated bolt fixing mechanism for the air filter (a standard range rover filter).

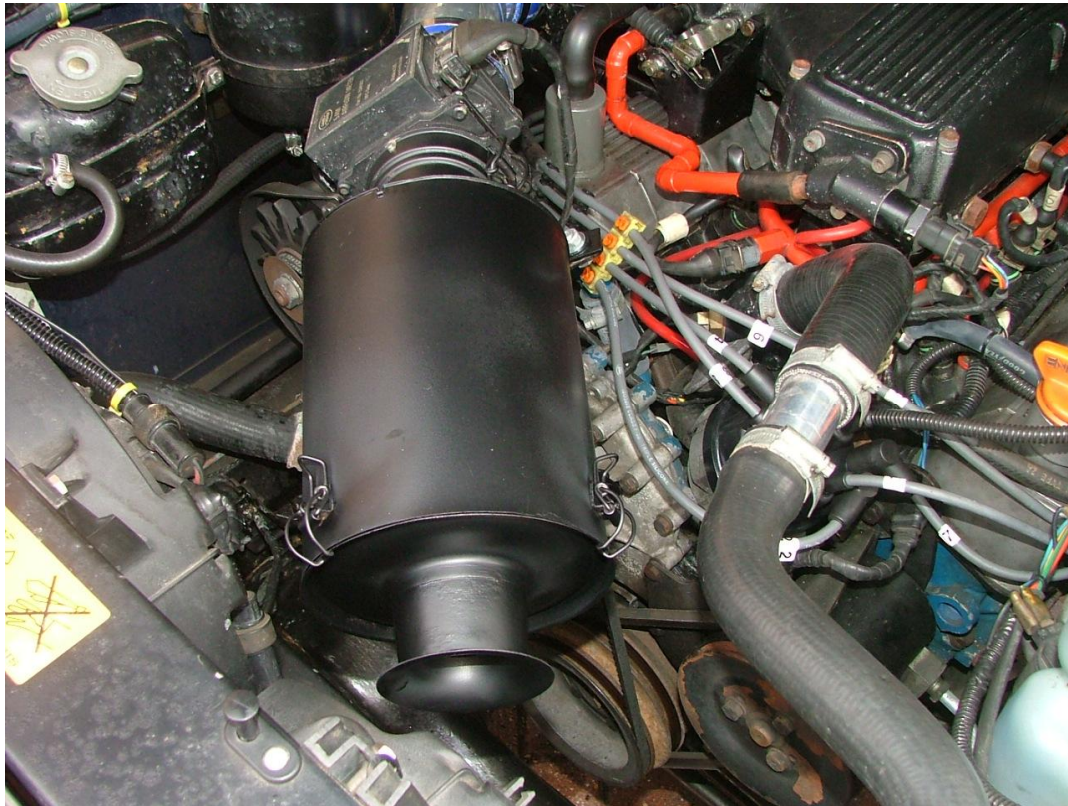
Figure 29 – Modified air cleaner box used to weather proof the intake air filter

While this air cleaner solution worked well in dry conditions it was less than ideal when driving in rain because any rain water passing through the radiator would hit and therefore dampen the paper air filter. This caused the element to loose its shape and its ability to properly seal. A second hand standard land rover air cleaner in fairly good condition was therefore purchased, cleaned and modified to shorten the snorkel so that it didn't foul the radiator fans. The finished result was then primed and sprayed matt black. See the two figures below for both views of the modified air cleaner.

Note in the above figure the shortened snorkel (which is much longer on a normal Land Rover air cleaner).

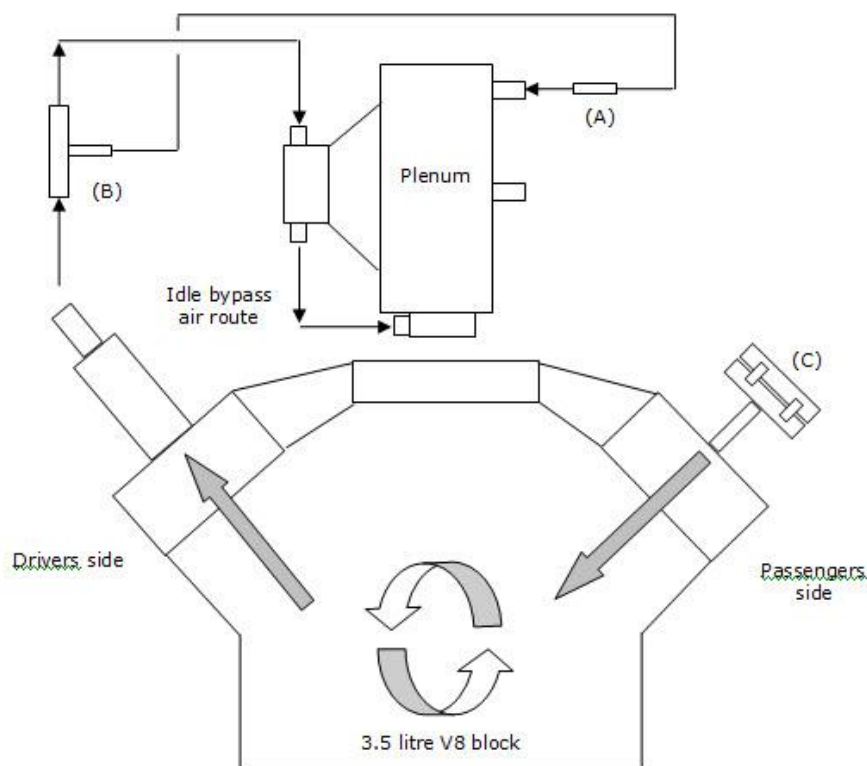
Figure 31 – PCV schematic

The standard PCV system is designed to draw un-burnt hydrocarbons resulting from blow-by past the piston rings, into the combustion process. This process removes hydrocarbons from the engine where they would otherwise reduce lubrication efficiency increasing wear (and emissions from the engine) while also creating a mild depression inside the engine to assist the gasket sealing process.

Note that the oil entry screw thread on the passenger side rocker cover isn't shown and that the original pipe on the back of the valley is blocked off and sealed.

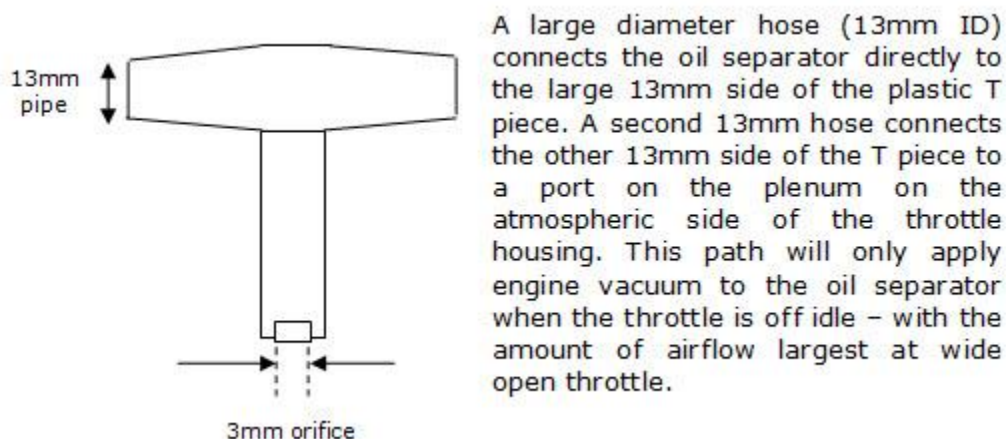
Figure 32 – Rover PCV coupling "T" piece

The passenger side rocker cover is fitted with a fixed small round metal T piece raised above the cover by perhaps 1cm (see (C) above). The stem of this T is drilled with a small 0.5mm hole passing into the inside of the rocker cover. A plastic shroud encases a gauze filter which clips onto the top of the metal T piece. Metered airflow draws into the engine via this filtered path and from there passes through the head into the main crankcase where it combines with oil and any hydrocarbons. It is then drawn out of the driver side rocker cover via a screw-in oil separator (see (D) above) which as the name suggests allows oil in the air flow to drain back into the engine while also acting as a flame trap in case of backfire. Airflow from the oil separator is drawn into the plenum via a T shaped plastic connector (supplied by Rover) and hose pipes.

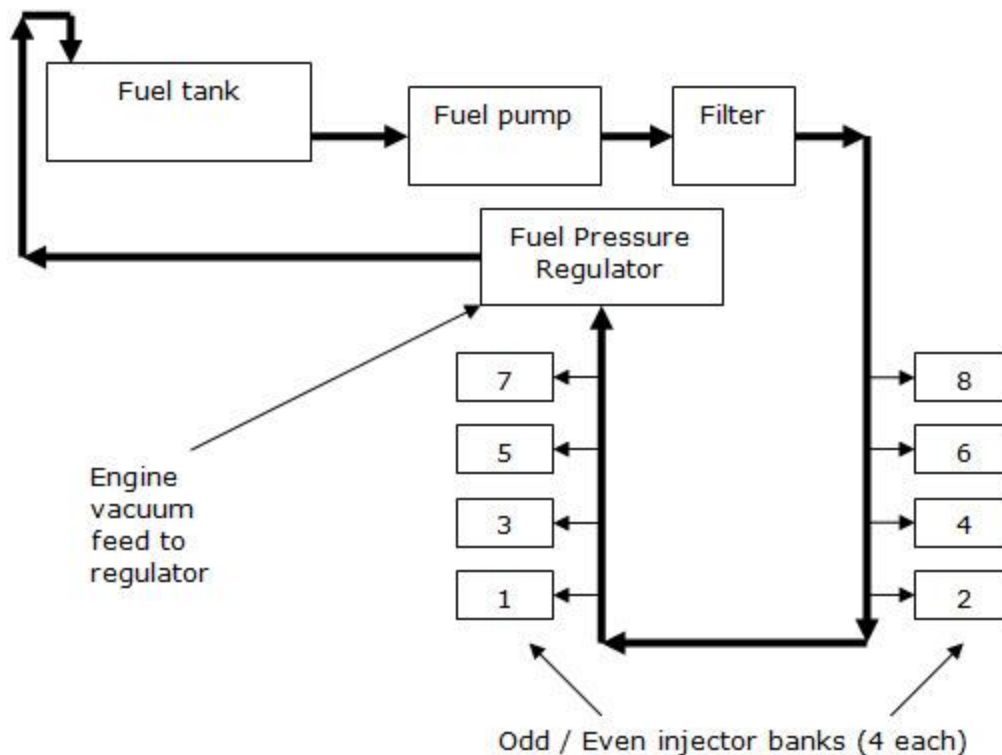
Figure 34 – Fuel system schematic

Fuel injection relies on high pressure fuel being delivered to the injector rail under all conditions. When the injectors open, the high pressure fuel instantly atomises into a fine spray and this effect greatly eases the traditional problem of vaporising fuel prior to combustion.

14CUX production implementations generally employed wet fuel pumps mounted inside the fuel tank along with non-serviceable gauze intake filters. The pump pressurises fuel to about 3 bar and delivers it to an inline replaceable filter and onto the fuel rail – connecting to all 8 injectors. At the distant end of the fuel rail, the pipe connects to the inlet of a fuel pressure regulator designed to regulate the pressure between 24 and 36 psi, relative to engine vacuum (the higher pressure obtained when vacuum is lowest and demand is greatest). The outlet of the fuel regulator returns excess fuel via a return pipe to the tank (at relatively low pressure).

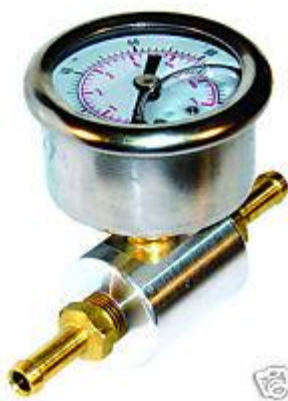
Figure 36 – Fuel pressure tap off point

The fuel line ran up the firewall to the rear of the engine – and then connected to an aluminium block threaded with three holes – two designed to accept 8mm hose ends, and a third tapped to suit a 1/8th NPT non-permanent fuel gauge. After testing this gel filled gauge was removed and replaced with a threaded block plug.

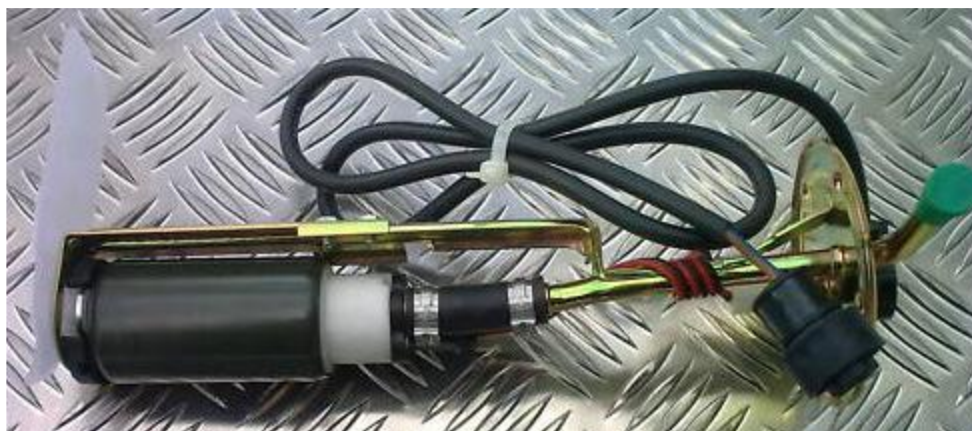
Figure 37 – Web pump for range rover classic (part number PRC 8318)

Range rover classic EFi vehicles (1986 to 1992) use a wet pump with part number PRC8318. An example is shown below.

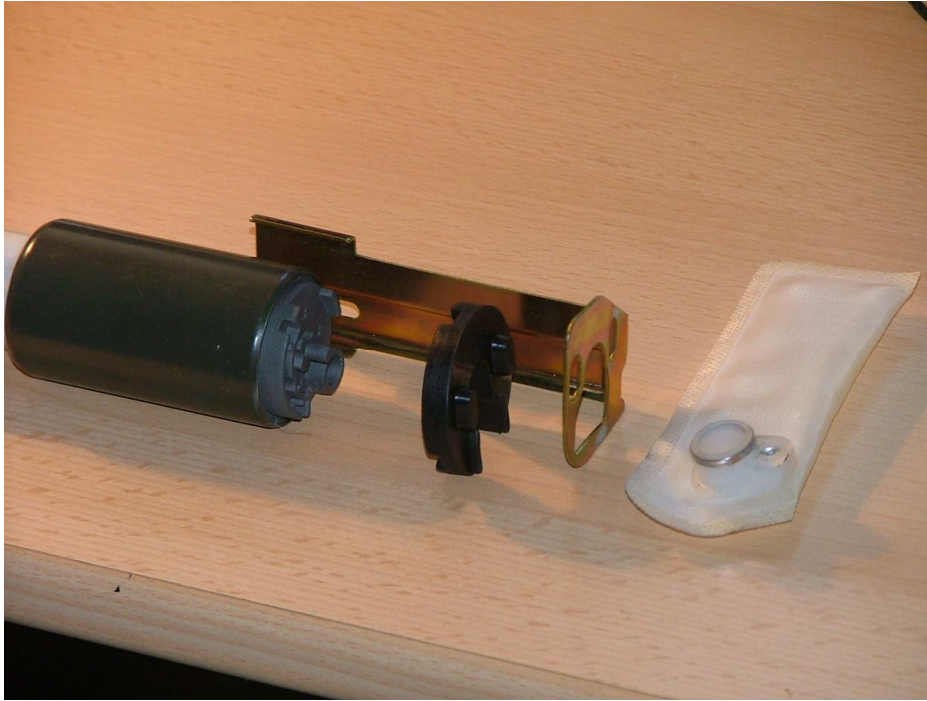
Figure 38 – Wet pump deconstructed

On the left side, the pump assembly consists of a white plastic porous filter allowing fuel to pass into a small but powerful, 3 bar pump via an 8mm opening. The pump output is coupled by a short hose to the 8mm pipe extending out through the cover mount flange plate complete with protective green cap. The lower end of the pump is supported by an L shaped steel bracket secured with two nuts (each having a small degree of adjustment) mid way up on its long side. The bracket is not secured to the bottom of the pump. Instead it fits over small extrusions on a rubber collar (see the black part below, sandwiched between the pump and the metal bracket). The fit is loose, but in such a way that the pump is cushioned (which helps reduce noise), supported vertically, and can't rotate

The pump support bracket is electrically earthed, and surrounds the fuel intake filter – providing an effective earth screen for incoming fuel, while also serving to physically restrain the pump. Hazardous fuels are often electrically screened to eliminate the build-up of static electricity as fuel flows into a rotary pump. This may seem like an esoteric safety feature, but over large production runs, especially when fuel tank levels become relatively low (giving rise to large volumes of air in the tank), there is a strong incentive to minimise any build up of static electricity.

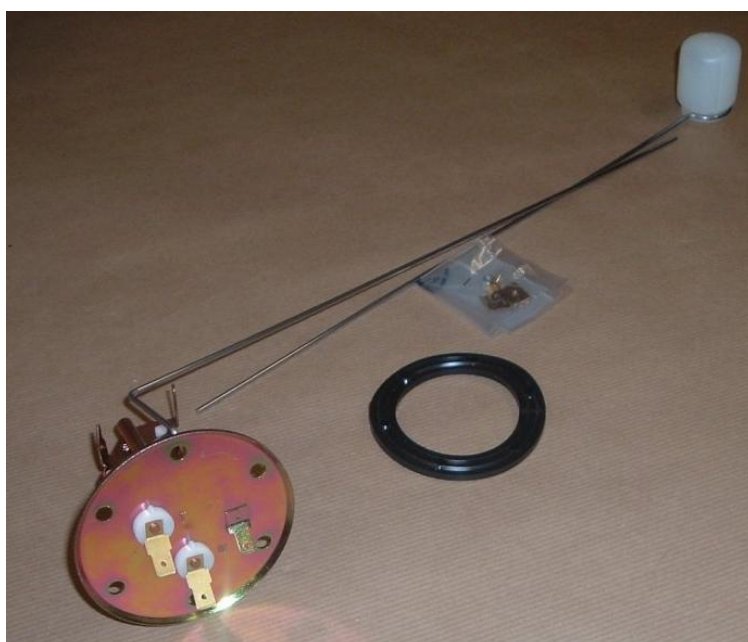
Figure 39 – Series III SWB petrol tank sender (part number 90560612)

Turning to the standard fuel sender for a SWB land rover Series 3 fuel tank – a new replacement fuel gauge sender has part number 90560612. A picture of the part from a land rover supplier is shown below. As can be seen from the photo below, this is actually a generic part, where the float arm is supplied as two components. The owner calibrates the float arm length using the two arms, and then solders one to the other.

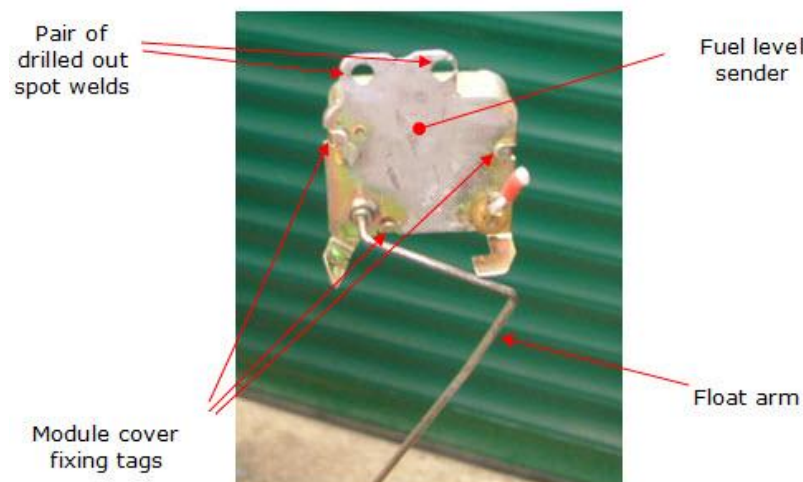
Figure 41 – Fuel level sender module – removed from Assembly A

The soldered connections (one wire, and one copper strip) were removed from the fuel sender module on assembly A. Then the two spot welds fixing the fuel sender module to the L shaped bracket were drilled to remove it as an electrically complete fuel level sender module – see below.

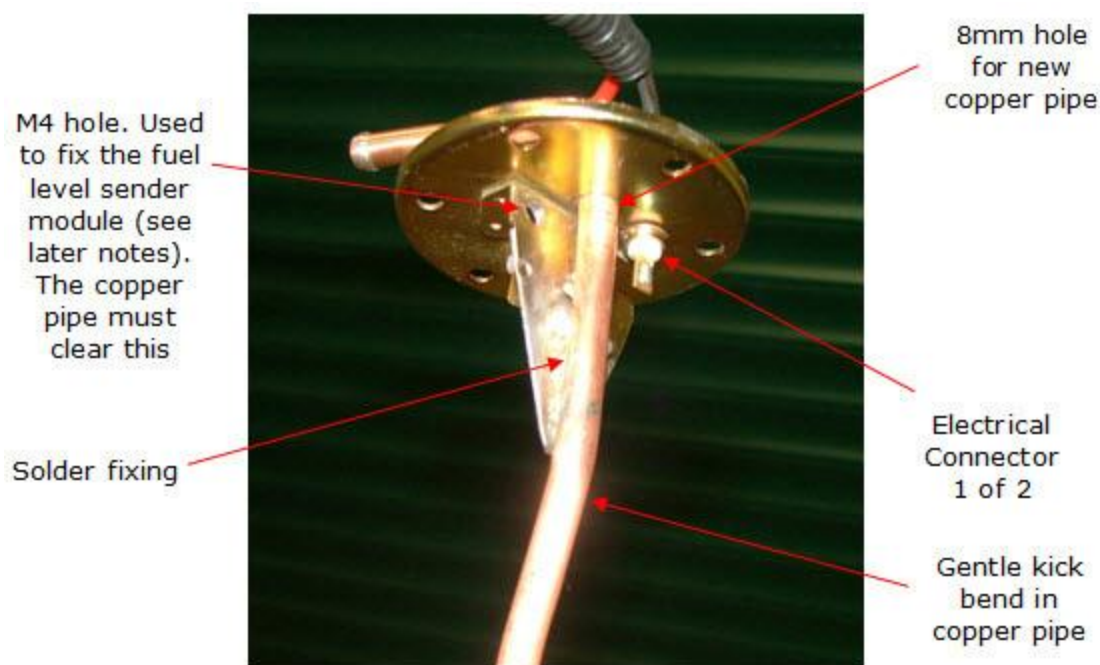
Figure 42 – Bare mounting flange, right angle plate and soldered feed pipe

An 8 inch length of 8mm OD copper pipe was then prepared. The pipe was cleaned, straightened, and then had a smooth right angle curve bend formed at the top – after which the L shaped piece was pushed through the mounting flange hole. The fit through this hole will be tight, but it is far from an interference fit (fuel would leak past this hole – see later notes).

When fully inserted, the loose pipe was then bent inbound starting at the bottom of the back plate (see “Gentle kick bend” in the figure below) to ensure it cleared the fuel sender float arm when at the fuel tank empty position.

The entire assembly, complete with loose copper pipe, was then turned upside down and placed into a bath of cold water to fully immerse the two electrical connections and therefore protect them from the heat of soldering. With the connectors protected, the copper pipe was then soldered to the back plate (see “solder fixing” above) to mechanically (and electrically) fix the pipe into position.

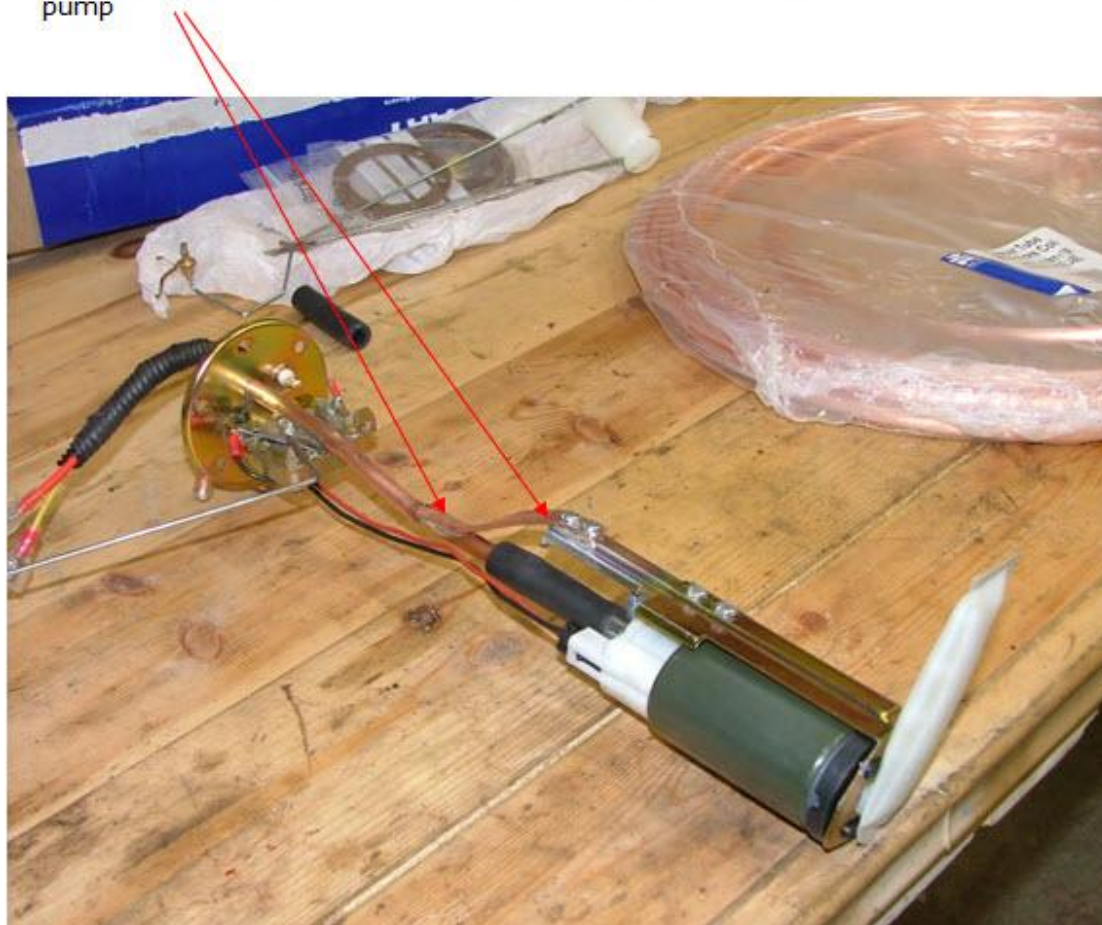
Figure 44 – Final complete assembly of the wet fuel pump design

This is the copper brace – and is made from 8mm copper pipe flattened in a vice. The end shown was hammer formed into a C shape, and soldered to the feed pipe. The other end was drilled, bolted and then soldered (to seal the screws) to the upper half of the original pump bracket. This secures the pump

The 8mm copper feed pipe passes through the mounting flange plate via an unsealed hole. Petrol and vapour will leak through this hole and it can't be soldered, because the heat would sacrifice the two electrical (plastic) sealed connectors. In addition, the new fuel level sender module taken from assembly A will be fixed to the back plate of assembly B using one M4 nut at the top which ensures electrical continuity, but it must also be secured lower down.

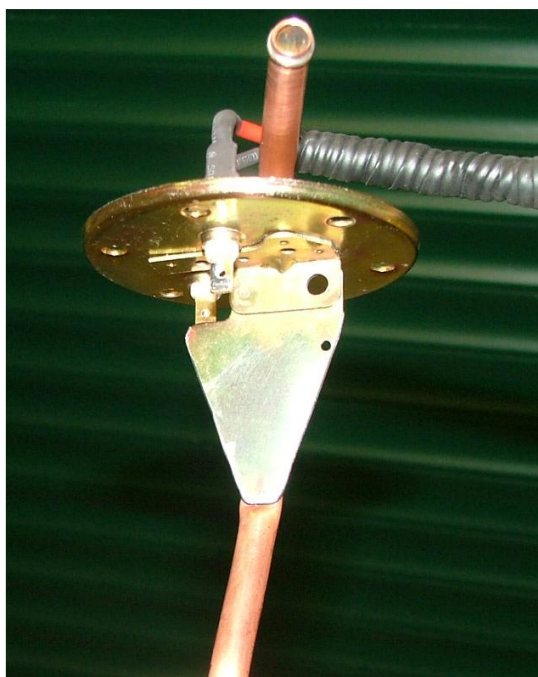
Figure 45 – Module side of the new assembly

Araldite 2022 has a different composition than standard Araldite available at DIY stores. It is characterised as having particularly strong resistance to petrol and was therefore the selected epoxy of choice. The reverse side of the new assembly shows the bare mounting position for the replacement electrical module – as shown below.

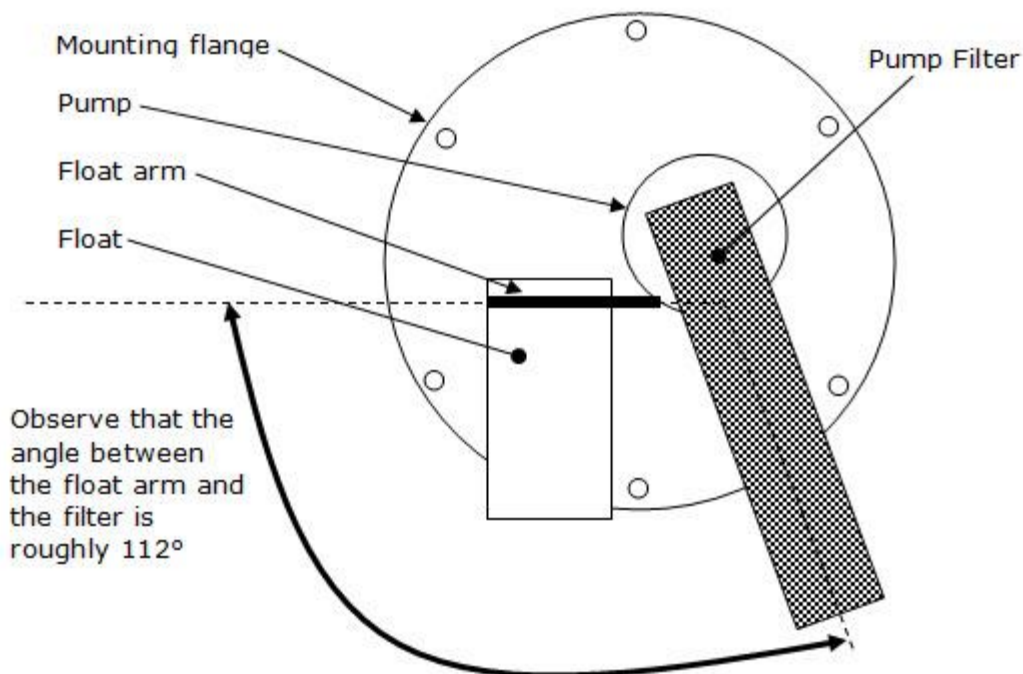
Figure 47 – Bottom up view of the full assembly (float drawn to the pump)

Viewing bottom up, the complete assembly would appear as follows:-

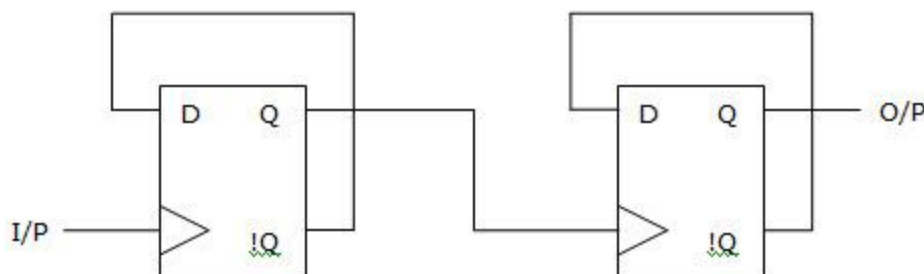
A possible solution based on a TTL 7474, which would require a regulated 5v rail, input conditioning and a Darlington pair driver for the output.
