# SERVICE INFORMATION

## STANDARD AND TRIUMPH VEHICLES (NOT FOR PUBLICATION)

**No.** EIGHT/2/M SUPPRESSION OF RADIO AND TELEVISION **Date** JANUARY 1954  
(AND OTHER MODELS) INTERFERENCE

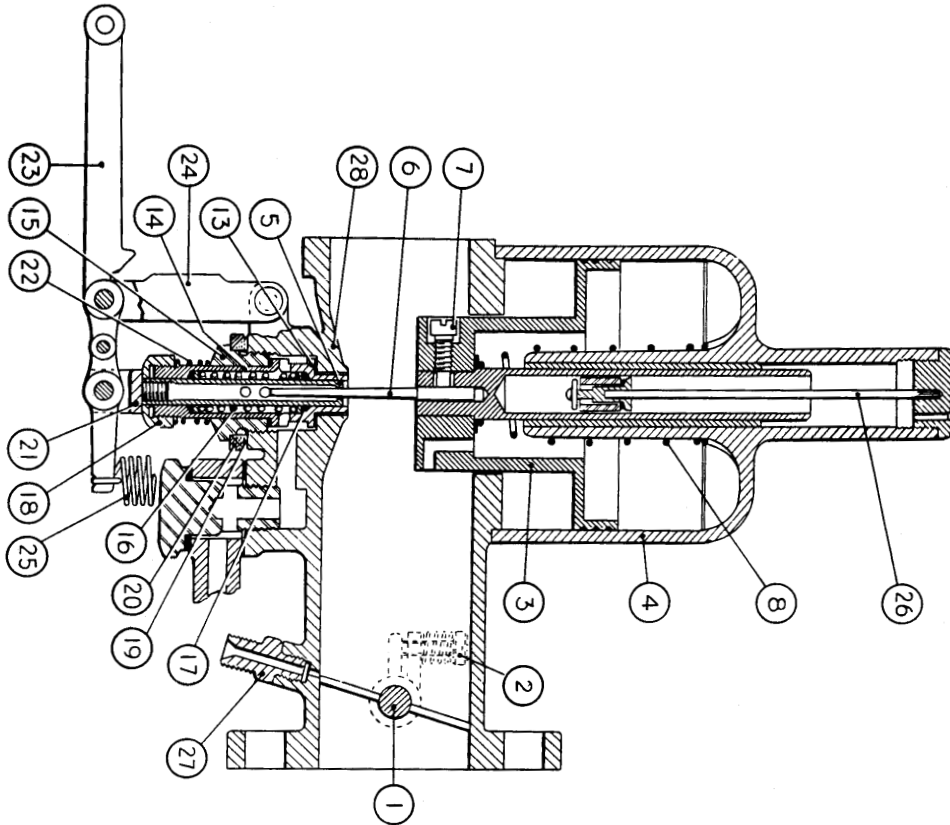
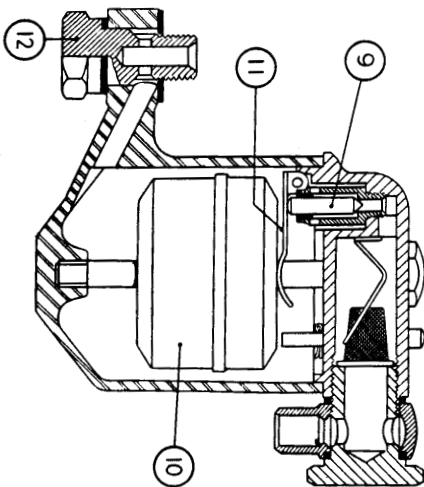
The shoulder of the needle should be flush with the seat of the needle jet. The correct datum point for each is shown.

#### Replacement of Jet Needle.
